Borella Geology, Inc.
Consulting Engineering Geology

Subject: Limited Geotechnical Investigation and Evaluation of Surface Soil conditions for Parking and Roads and Areas where Storm Drain Outlet Pipes enter into Drainage Catch Basins.

Appendix 1: Exploration Trench Logs

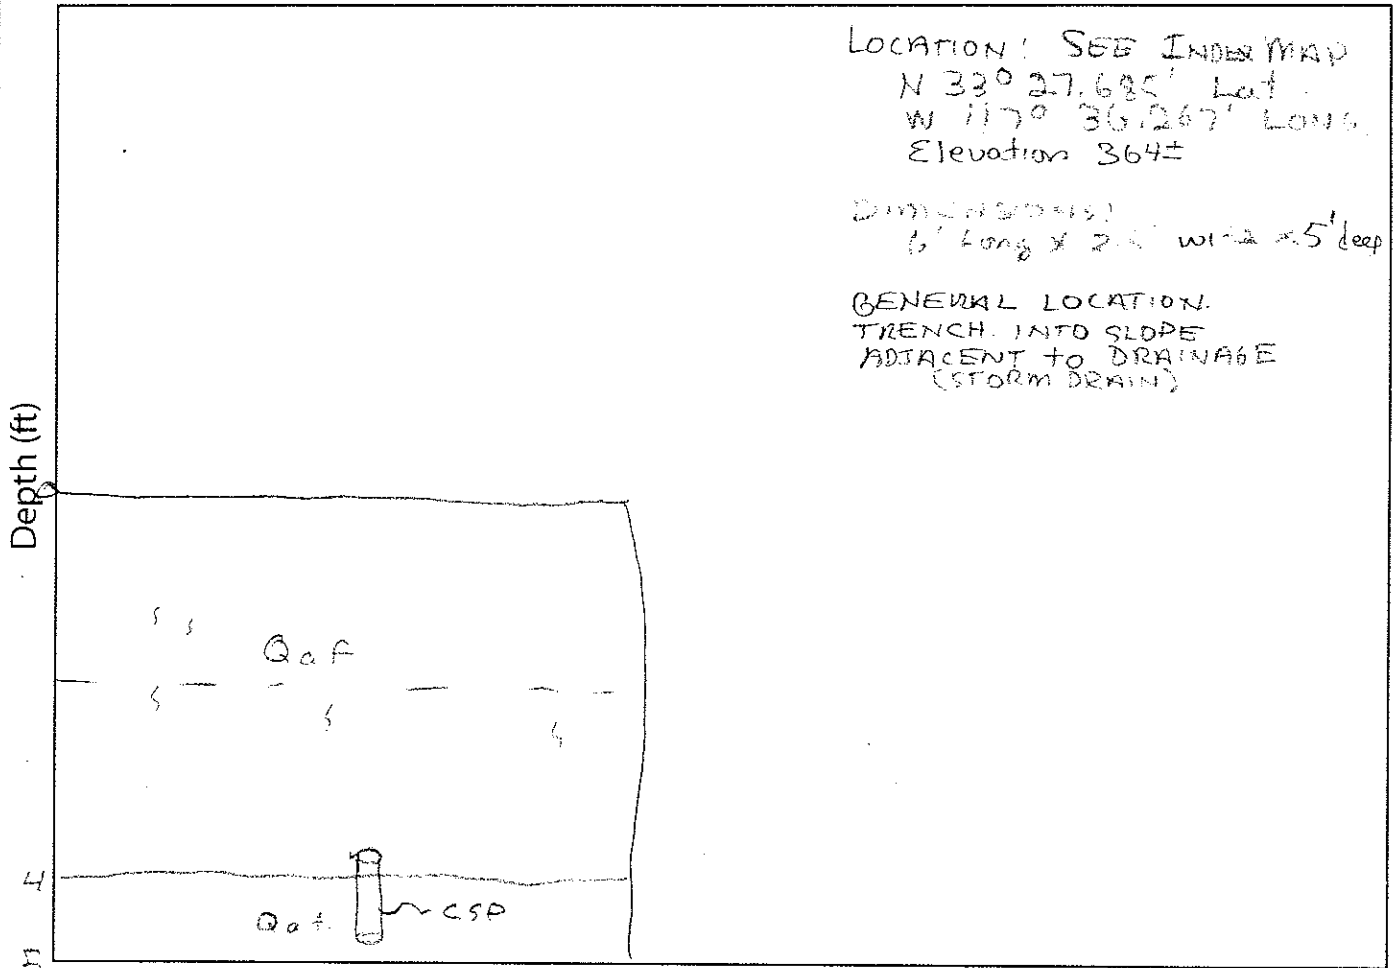
Trench Number: T-1

- ENGINEERED FILL
- 0-4' Qaf - Artificial fill, very dry, crumbles, silty clay to clayey silt - No water - Hairline roots to 3 feet - Weathered - Tan to light tan
 - 4-5' Qat - Fill more competent - Silty clay to clayey silt - Gray to light Brown

Blow counts @ 4-5' with CSP 100 blows/6 in.
 40 lb. hammer. 1.5 foot Drop.

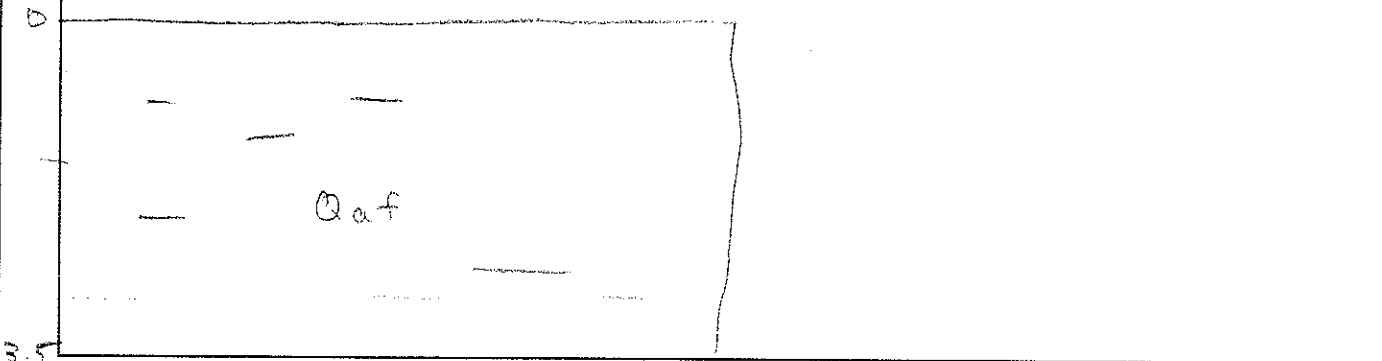
Trench Number: T-2

0-3.5 - Qaf - Artificial fill crusty, upper 1-1 1/2' weathered flakey, very dry

1.5-2' silty clay with fragments of (Tm-Monterey Formation)

2-3.5 - more competent, medium dense greenish gray to gray.

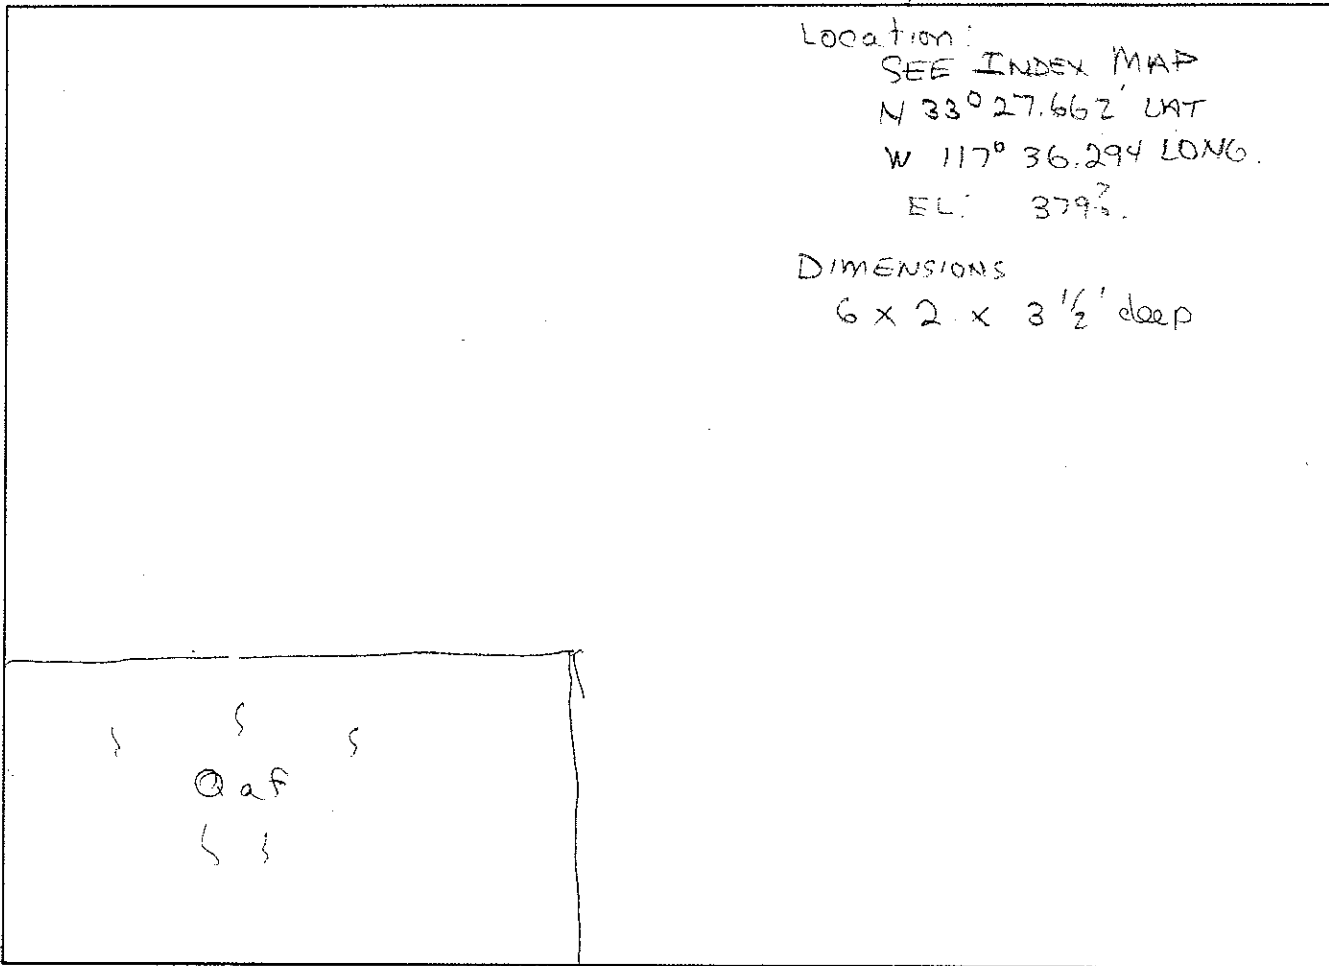
Trench Number: T-3

0 - 3.5' - Qaf - Engineered F.1 - light tan to yellow brown to reddish brown. sand silt to silt w/ sand & clay, tight

Upper 6" - 1 crumbly

Tighter & better moisture content than T-1 & T-2, No Roots

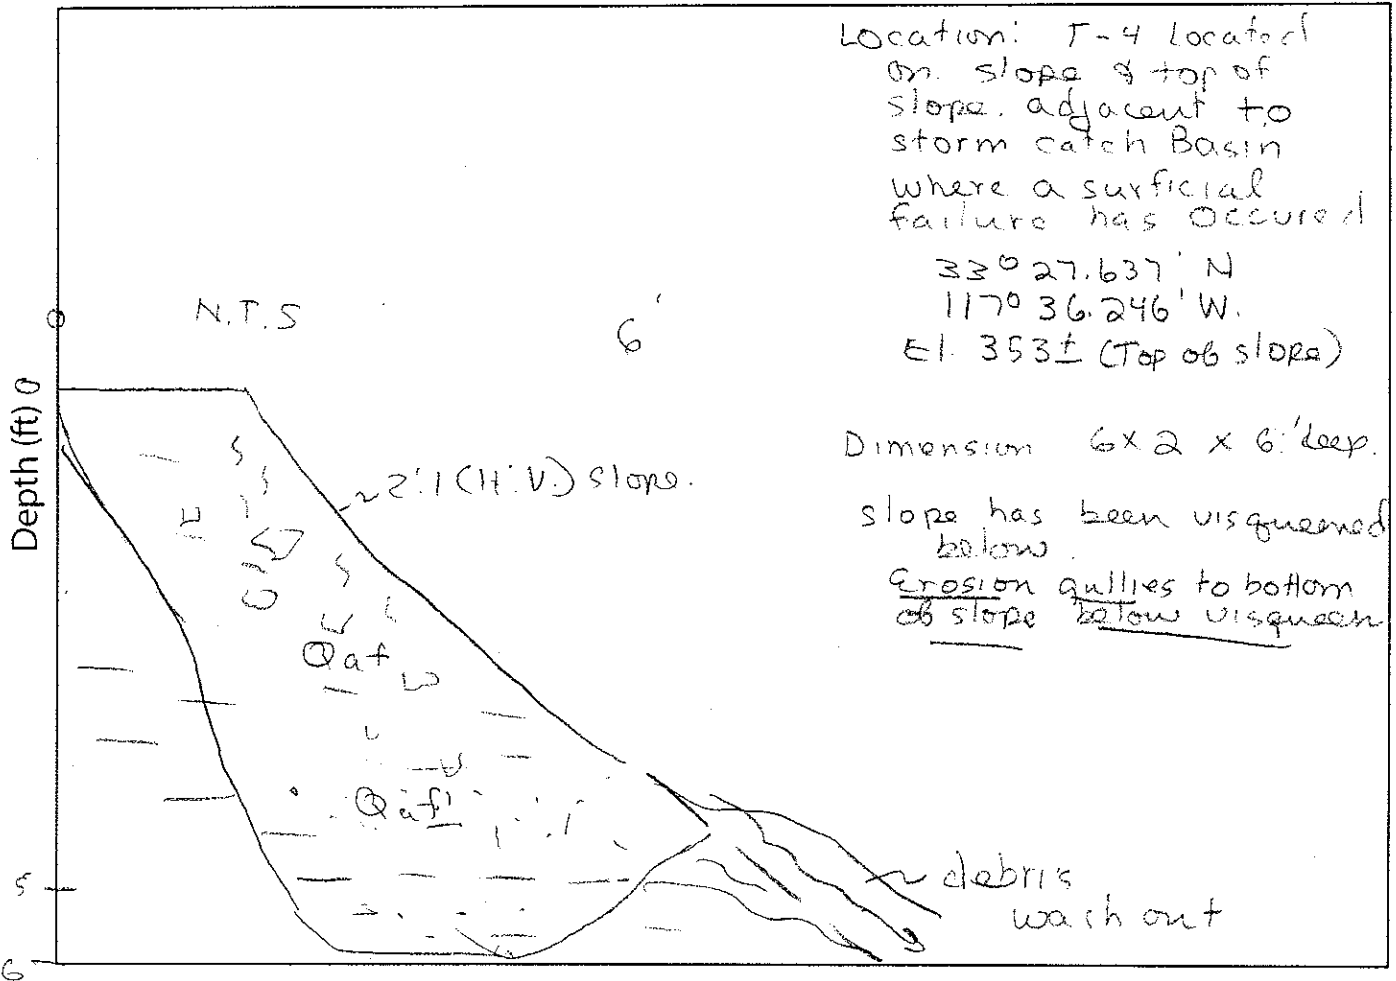
Trench Number: T-4

Location: T-4 located on slope & top of slope adjacent to storm catch Basin where a surficial failure has occurred

slope has been visqueered below

erosion gullies to bottom of slope below visqueered

0 - 4 to 5' - @af - loose, desiccated and slumped debris dry crumbly - fill NOT compacted, easily excavated w/ backhoe
Hardline rootlets down to 1.5 feet

@ 5' Soil appears competent tight, medium dense better moisture content
Light tan silty clay to clayey silt fragments of Tm (Monterey Formation)

* Bottom of slope in this area is in bad shape

Assume creep depth to at least 5'

anchors as well as soil Nails may be needed

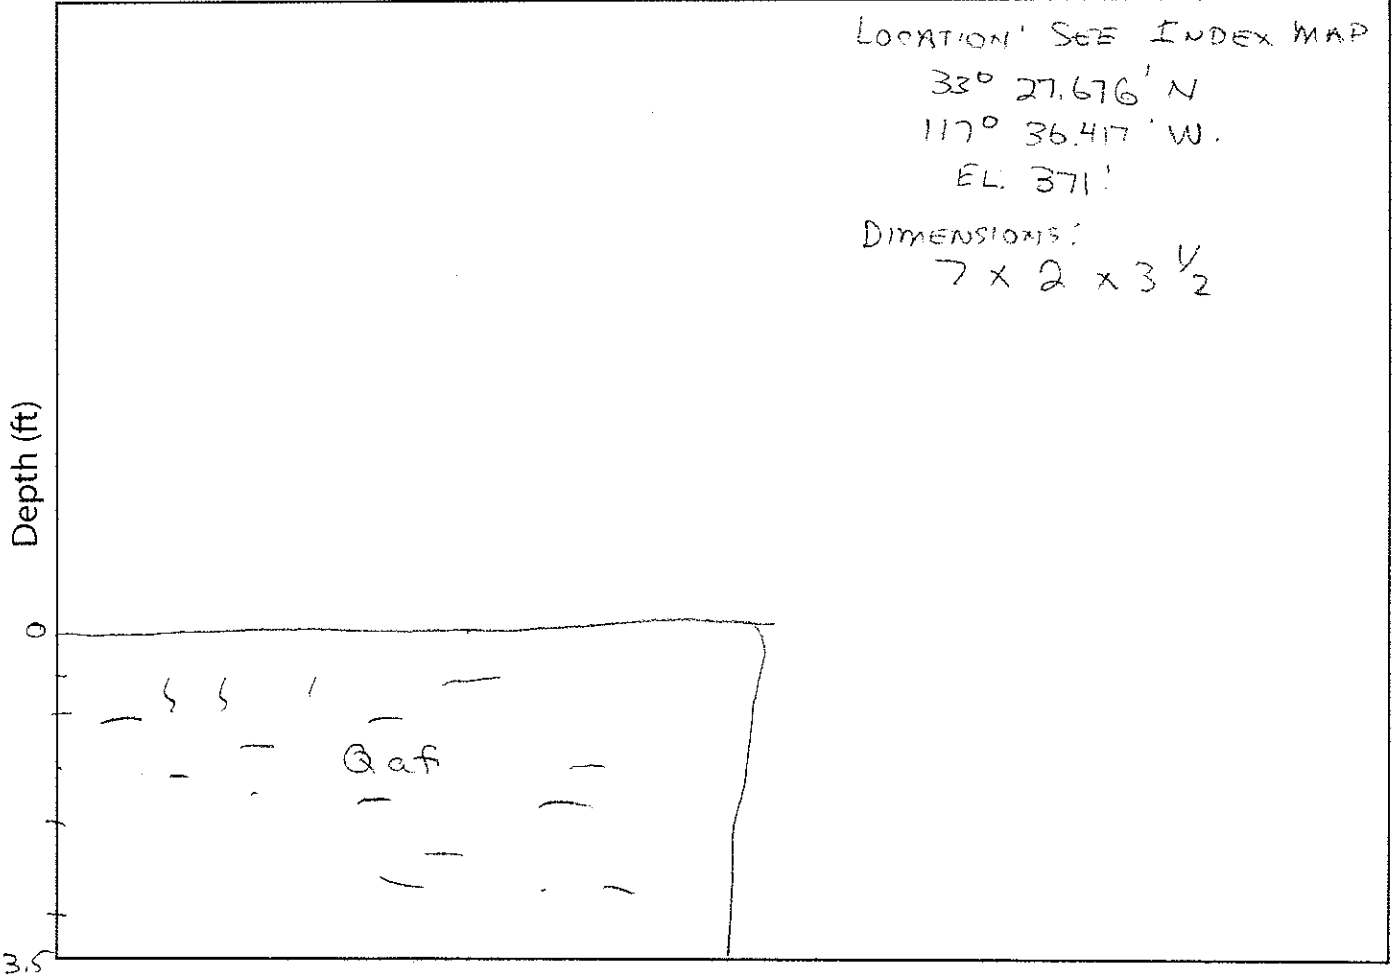
Trench Number: T-5

0 - 3 1/2' Qaf - Artificial Fill - Tan to brown
silty clay - No roots Fair moisture, clean
medium dense to tight.

Upper 6" - 1' Loose,
plastic zone at 2'
